CONNECTICUT RIVER BASIN
BATH, NEW HAMPSHIRE

RYEGATE PAPER COMPANY DAM
NH 00014

PHASE I INSPECTION REPORT
NATIONAL DAM INSPECTION PROGRAM

JUNE 1979

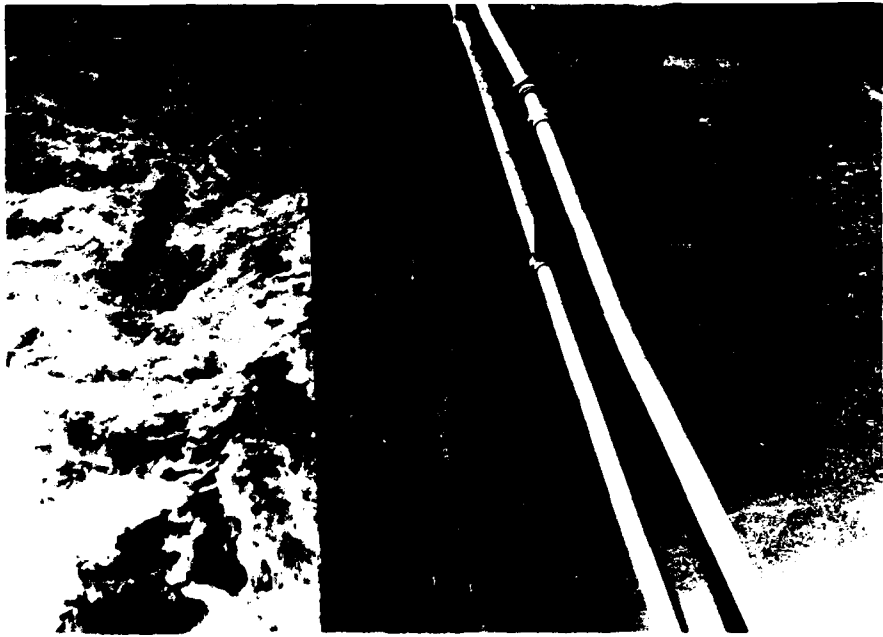
The training wall was observed to be in fair condition. All sides of the wall revealed some surface deterioration to a maximum depth of six inches. (See Appendix C-Figure 6.) A hairline crack was noticed at the center of the wall and having an east-west orientation approximately opposite the crest of the dam. (See Appendix C-Figure 7.) Considerable efflorescence was observed on the sides of the wall at cracks. (See Appendix C-Figure 6.) Also rust staining was observed at embedded steel items.

(3) The deteriorated condition of the training wall.

Figure 6 - View of the surface deterioration of the training wall.

(2) Investigate, design, and construct repairs to correct the deteriorated portions of the training wall.

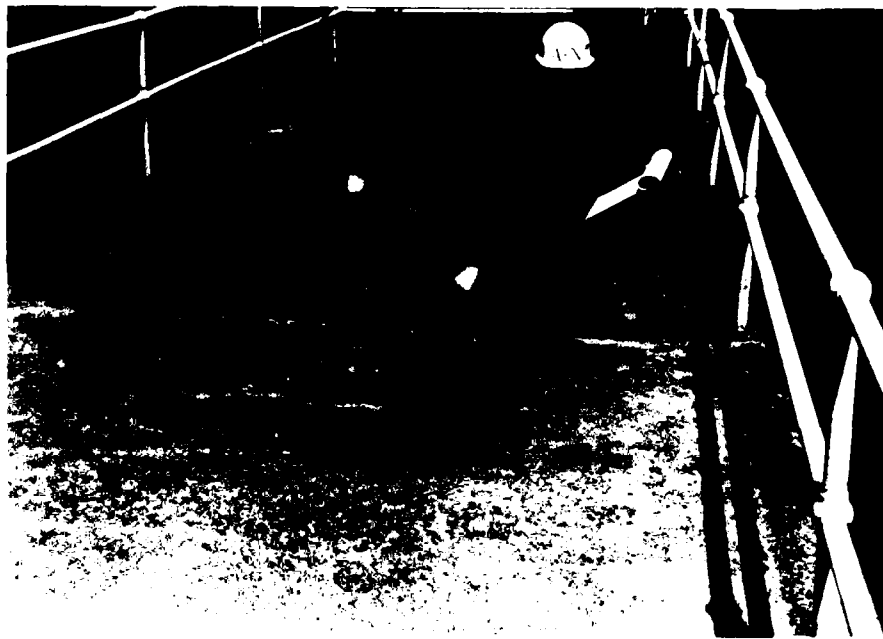
Figure 7 - Looking at the transverse crack in the center of the training wall.

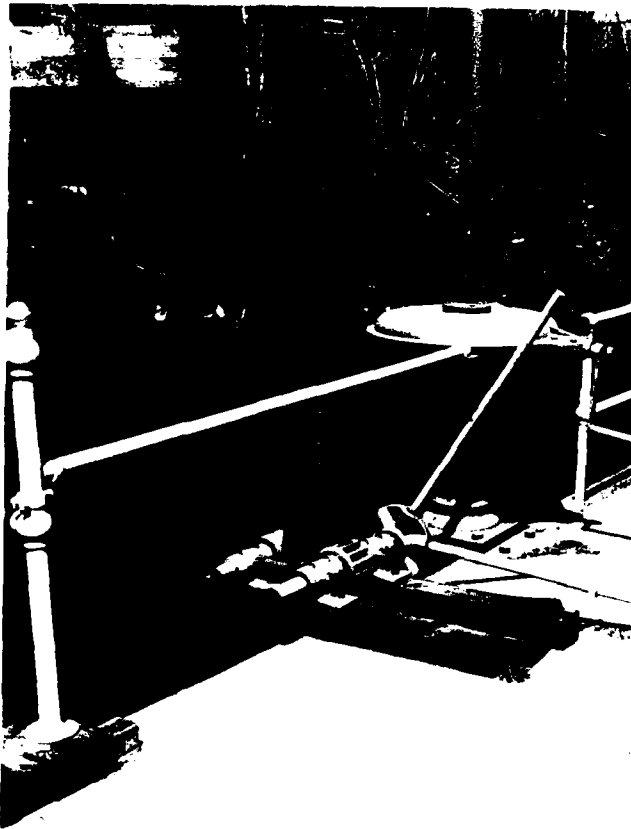
High and low-level outlets exist through the training wall which have a capability to discharge flow from the grinder building inlet channel to the tailwater pool. The low-level outlet and slide gate was submerged on the day of the inspection and therefore could not be inspected. (See Appendix C-Figure 8.) The single shaft, completely enclosed, crank operated mechanism were observed to be in good condition. (See Appendix C-Figure 9.) The dimensions of the high-level outlet could not be accurately determined due to the flow through the structure. A 4' wide by 5' high steel gate and operating mechanism were observed to be in good operating condition. (See Appendix C-Figure 9.)

Figure 9 - Looking at the gate mechanisms which control the high-level and low-level gates.

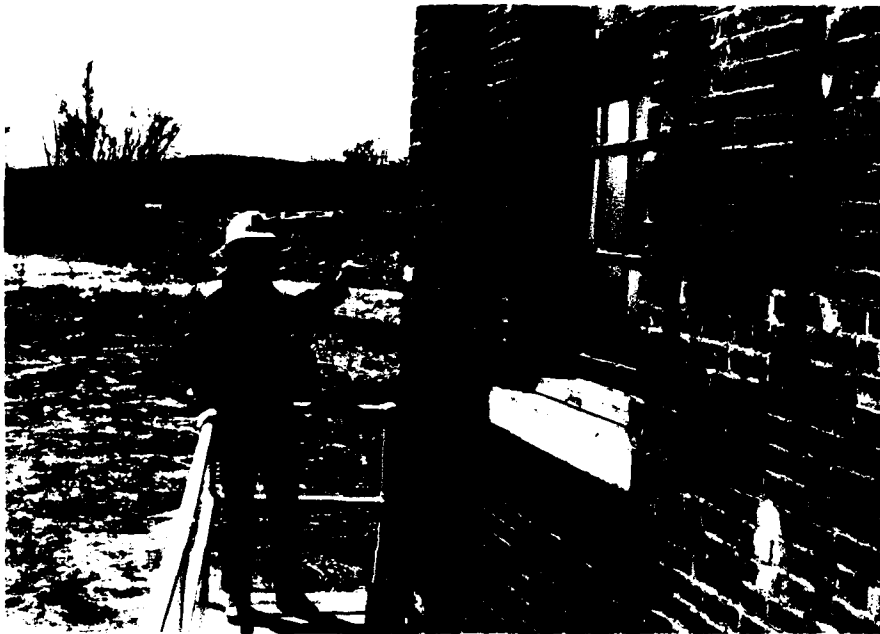
Figure 14 - View of the 1936 flood highwater mark.
